**51 & 53 EAST CLAREMONT STREET PLANNING NOTES - EXTERNAL ITEMS**

**MR. & MRS. W. CLARK**  
PROPOSED ALTERATIONS TO  
51 & 53 EAST CLAREMONT STREET,  
EDINBURGH.

**EXISTING & PROPOSED  
ELEVATIONS & SECTIONS  
SITE & LOCATION PLAN**

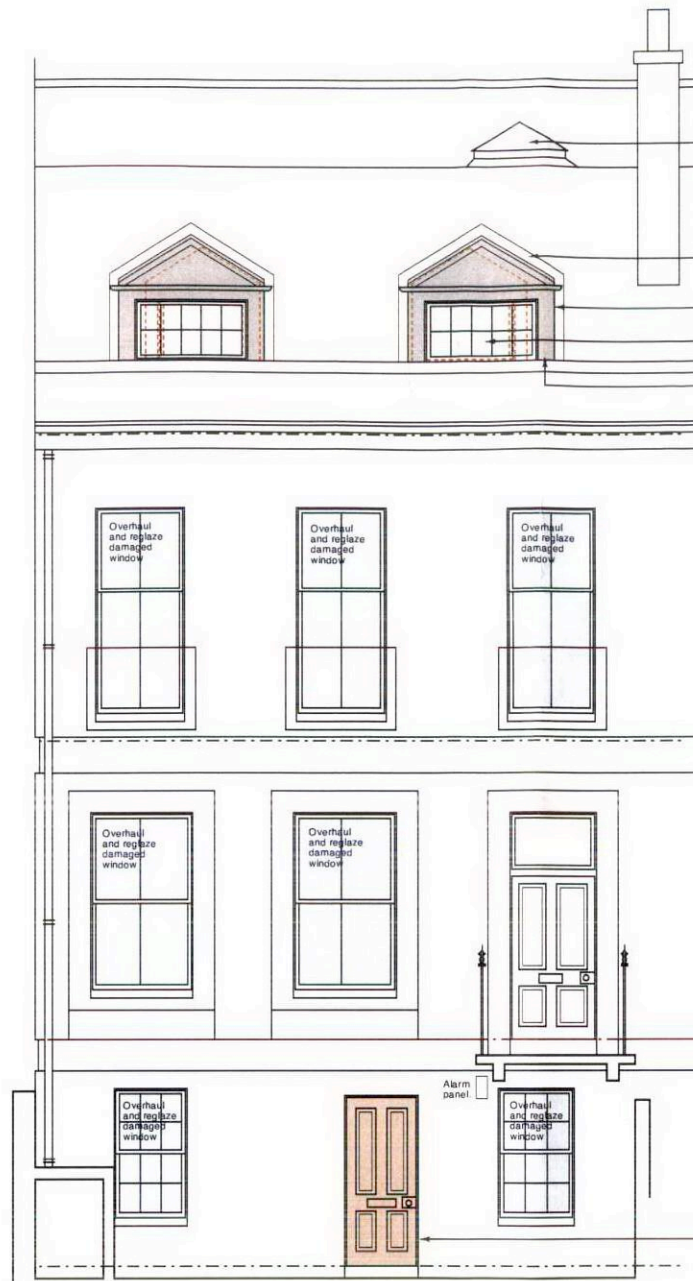
PROPOSED FRONT ELEVATION  
SCALE 1:50

Existing cupola removed following fire damage. Form new cupola over main stair well to best replicate Georgian style with timber frame and lead cladding externally.

Slate pitched roof with lead flashings to match existing.

Increase width of existing dormer windows to match adjacent property at No. 57 East Claremont Street.

Reinstate astragals.

Dormer windows clad in lead to match existing.

- 4. CUPOLA**  
Cupola at stairwell to be reinstated where missing to traditional street pattern with toughened double-glazed safety panes.
- 5. DORMER WINDOWS**  
Existing dormer windows to be removed and replaced to form and profile to replicate those adjoining no. 55 and 57. New dormer to be clad in lead to British Lead Sheet technical specification with traditional sash and casement windows. Front wallhead gutter to be reformed and front pitch reslated in attendance.
